**SANITARY DISTRICT NO. 5 OF MARIN COUNTY
2001 Paradise Drive
Tiburon, California 94920**

**Capital Improvement Program Committee Meeting
Tuesday September 14, 2021, 5:00 p.m.**

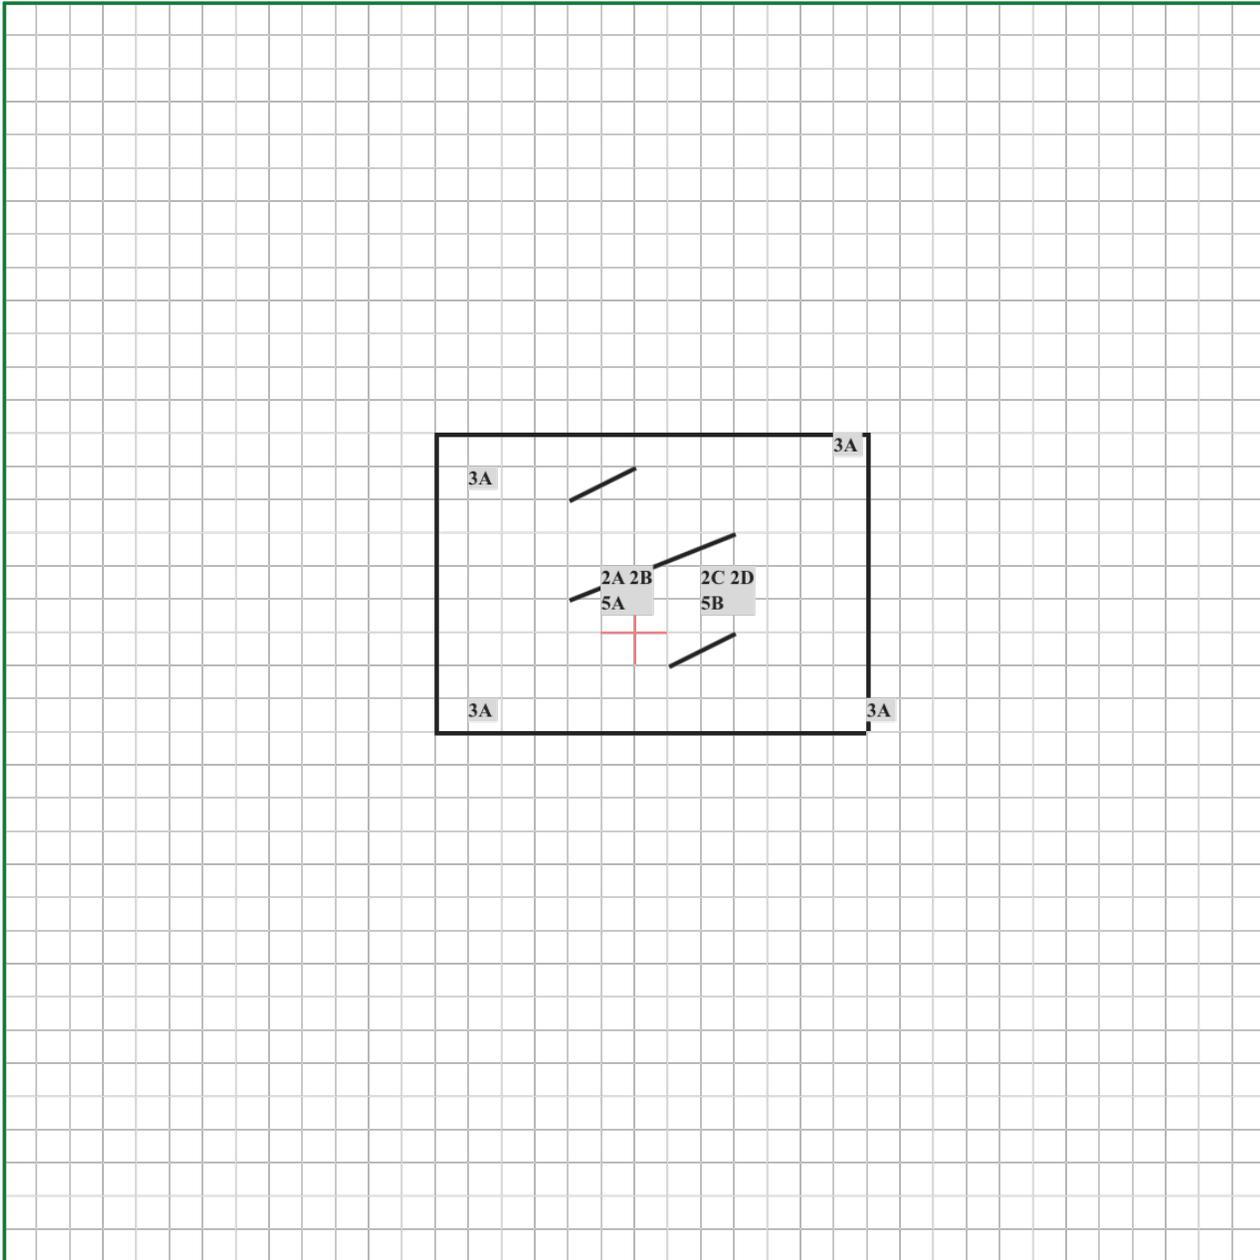
NOTE: Questions or problems concerning the above report should be directed to the manager of the company. Unresolved questions or problems with services performed may be directed to the Structural Pest Control Board at (916) 561-8708, (800) 737-8188 or www.pestboard.ca.gov. 43M-41 (REV. 04/2015)

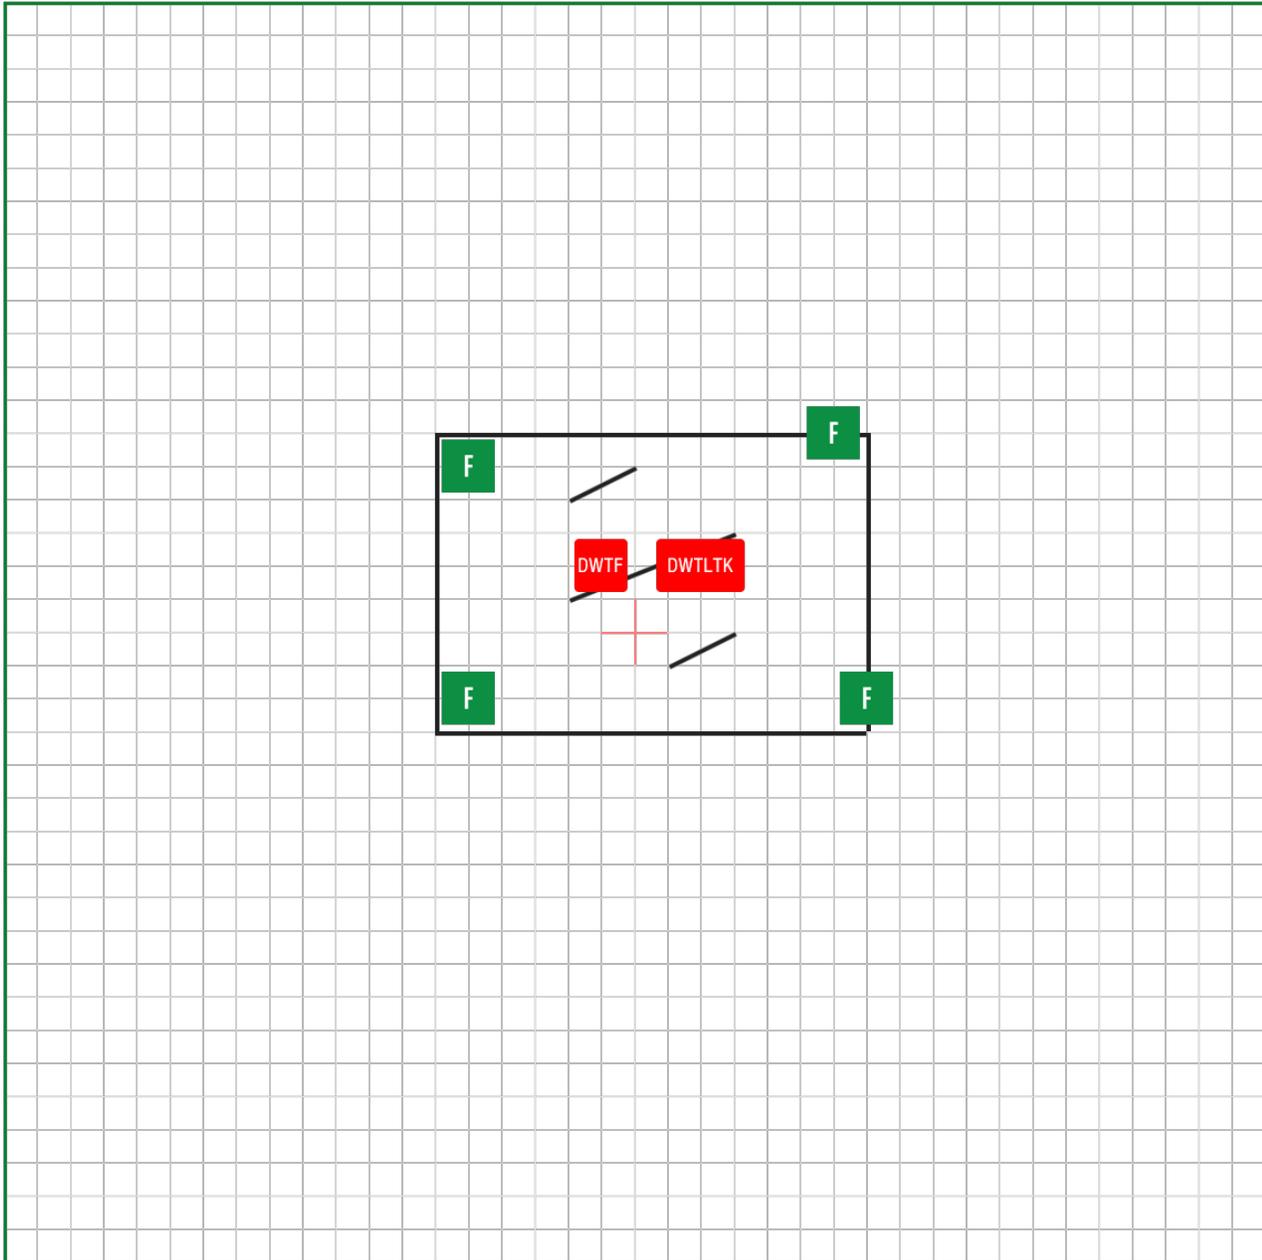
Inspector: ALLISON, FRANK
