**SANITARY DISTRICT NO. 5 OF MARIN COUNTY  
2001 Paradise Drive  
Tiburon, California 94920**

**Capital Improvement Program Committee Meeting  
Tuesday, April 13<sup>th</sup>, 2021, 2:00 p.m.**

# Renewable Energy Study

# Collection System Master Plan

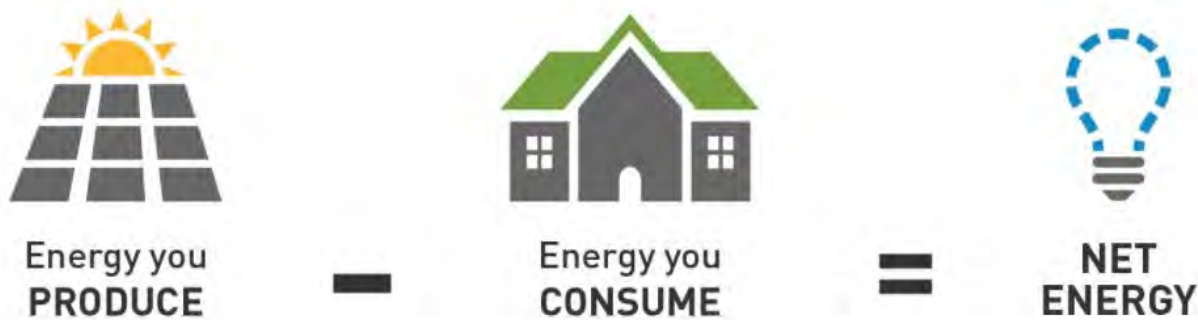
**Figure 6 – Energy Net Metering**

NEM is the process through which owners of on-site renewable energy systems are credited for the renewable energy that is generated and added to the grid. This allows owners to utilize electricity whenever it is needed, rather than when it is produced. Each month, the owner is credited for each kWh of electricity generated, and then billed against that credit for each kWh of electricity used. During periods of peak generation, the credits may exceed the amount of electricity used, with the additional credits carrying over to future months to offset periods of time the amount of electricity generated is less than the amount of electricity used. Over the course of a 12-month period, the owner will be billed or reimbursed for the delta between the amount of electricity generated compared to the amount of electricity used, with net usage being billed monthly.

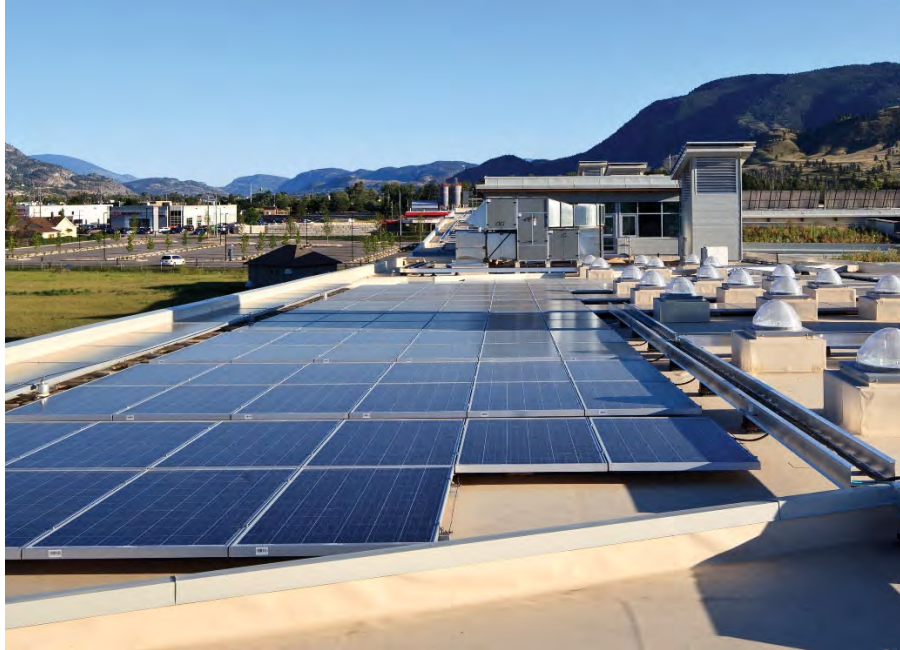
**Figure 8 – Example, Roof Mounted PV System**

Roof mounted systems allow PV modules to be located on both steep and low-sloped roofs. The racking systems can mount the PV modules perpendicular to the slope of the roof, or they can provide a custom tilt to maximize generation based on the solar access for the given site. Roof mounted systems are proposed for the Main Tiburon WWTP and a few of the pump stations.

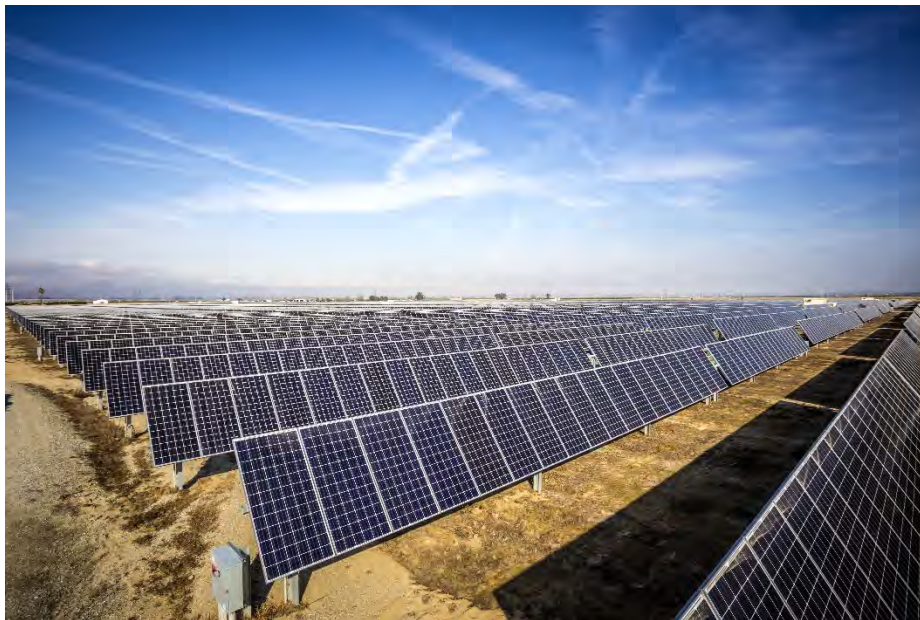
**Figure 9 – Example, Ground Mounted PV System**

Ground mounted systems allow PV modules to be placed in areas of open space. The racking systems can mount the PV modules at any angle to maximize generation based on the solar access for the given site. Ground mounted systems are proposed for the hill adjacent to the Main Tiburon WWTP.

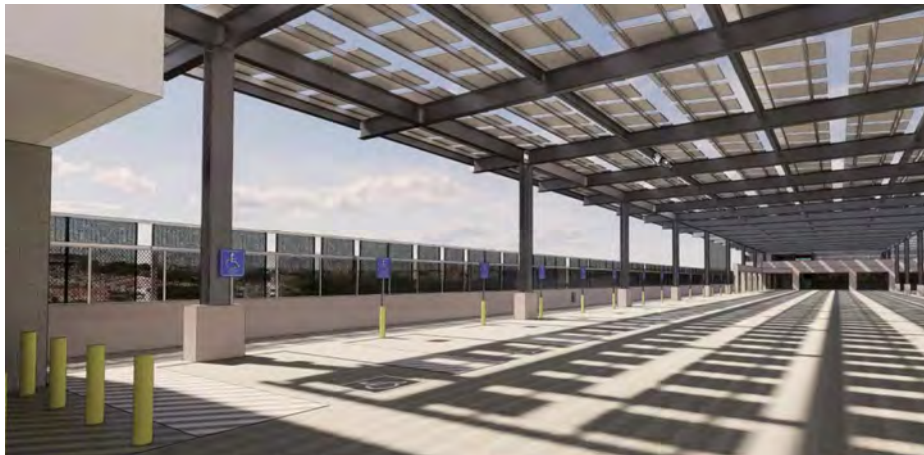
**Figure 10 – Example, Canopy Mounted PV System**

Figure 10 shows an example of a canopy mounted system that spans an entire area. Depending on the length of the span, the structural columns can be located at the edges of the structure, leaving the area underneath canopy clear of obstructions. This canopy system is a good option for the Main Tiburon WWTP and the Paradise Cove WWTP, where it could span above any buildings and rooftop equipment. This maximizes the solar area by minimizing the area required for setbacks and access aisles.

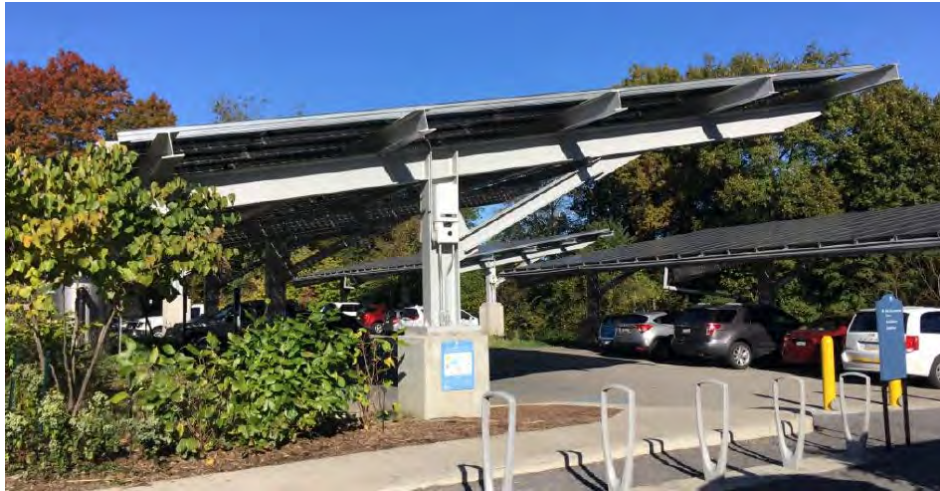
**Figure 11 – Example, Carport Mounted PV System**

Figure 11 shows an example of a carport canopy mounted systems. These structures are commonly located above the parking spaces in a parking lot, while the drive aisle is open. The structural columns are in the middle of the canopy, with the PV modules placed on cantilevering beams to span the planned width. The entire canopy is generally tilted at a set angle, which butts the PV modules together and eliminates spacing requirements. These systems are good options for a number of pump stations.

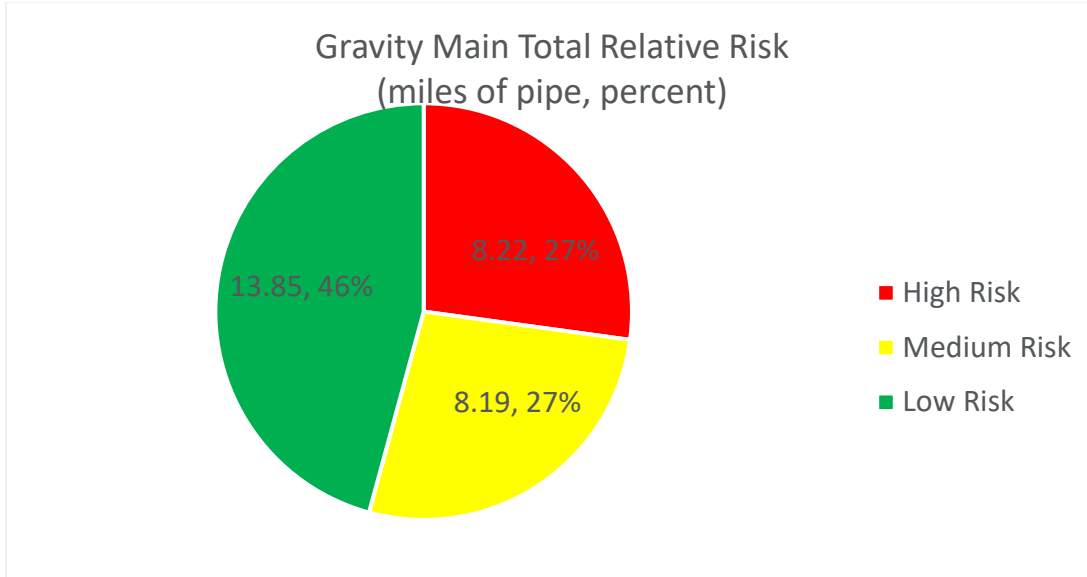
**Figure 2. Risk modeling results for gravity mains**

The LoF and CoF scores are comprised of several components based on physical characteristics of the system, CCTV inspection results, regulatory history and customer service. These were tabulated for every gravity main to develop the final risk score. The risk model for the system, summarized in Figure 2, shows that about 27 percent (8.22 miles) of the gravity mains have a relatively high risk compared to the rest of the system. However, these pipes do not all require rehabilitation.

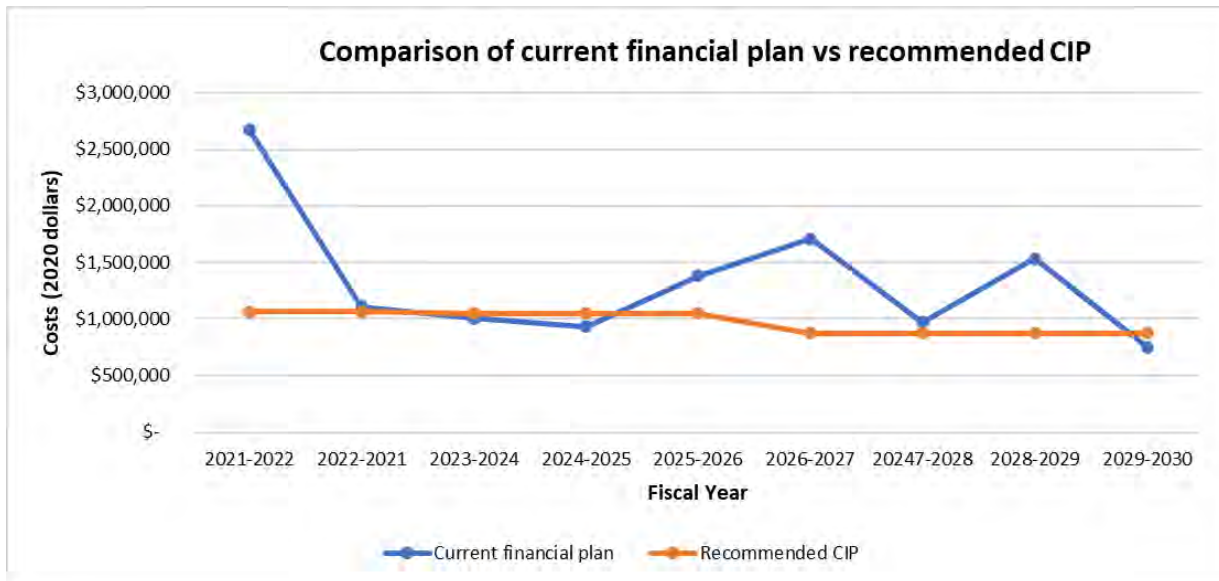
Figure 4. Comparison of the recommended CIP and the SD5 financial plan

Figure 4 compares the existing SD5 capital plan as provided in the FY 2020-2021 Final Budget report (SD5, 2020b) to the recommendations from this master plan. The planned budget averages approximately \$1.2 million whereas the recommended projects from this Master Plan average approximately \$1.0 million over the same time period.

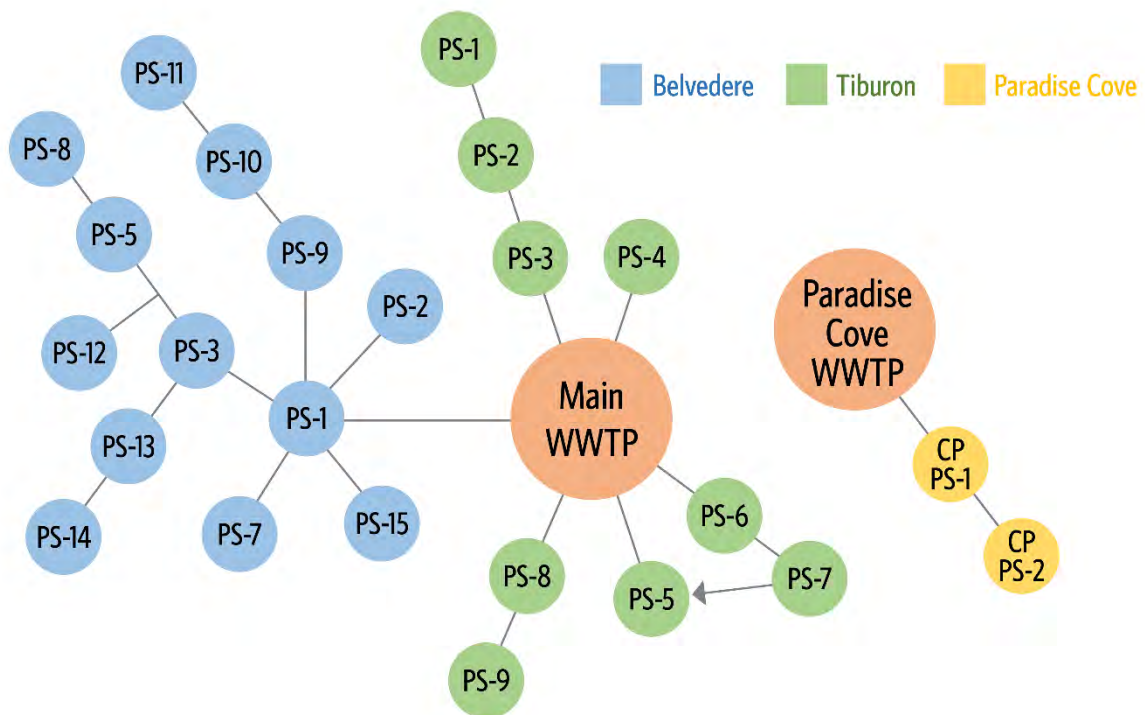
SD5 collection system infrastructure is divided into two systems as shown in Figure 6: (1) the Main Treatment Plant collection system, which services all of the City of Belvedere and the southeastern and central portion of the Tiburon peninsula and (2) the Paradise Cove collection system, which services the northern portion of the Tiburon peninsula along the coast. In these two systems, SD5 manages about 30 miles of gravity pipelines, which include 772 manholes, 98 rod holes, and 19 cleanouts (Figure 7). Where gravity flow is not viable, SD5 pumps wastewater to its treatment plants through 24 lift stations and about 4.5 miles of force mains. Each of these systems is described in more detail in the following paragraphs. Information provided is based on SD5s geographic information system (GIS) database (SD5, 2020a).

**Figure 6. SD5 collection system schematic. Tiburon PS-7 flows can be diverted to PS-5 during non-normal flows scenarios.**

A schematic of the lift stations and how they pump water to the treatment plants is shown on Figure 6. Tiburon lift stations PS-3, PS-5, PS-6, and PS-8 are main collection points in the Tiburon service areas, receiving all wastewater from other lift stations and the remaining parts of the collection system (Table 10). In the Belvedere service area, all flows are received at PS-1, which pumps directly to the Main treatment plant. Other important Belvedere lift stations include PS-2, PS-3, and PS-7 which collect wastewater from 44 percent, 32 percent, and 63 percent of the service area by miles respectively (including gravity mains that flow into upstream lift stations).

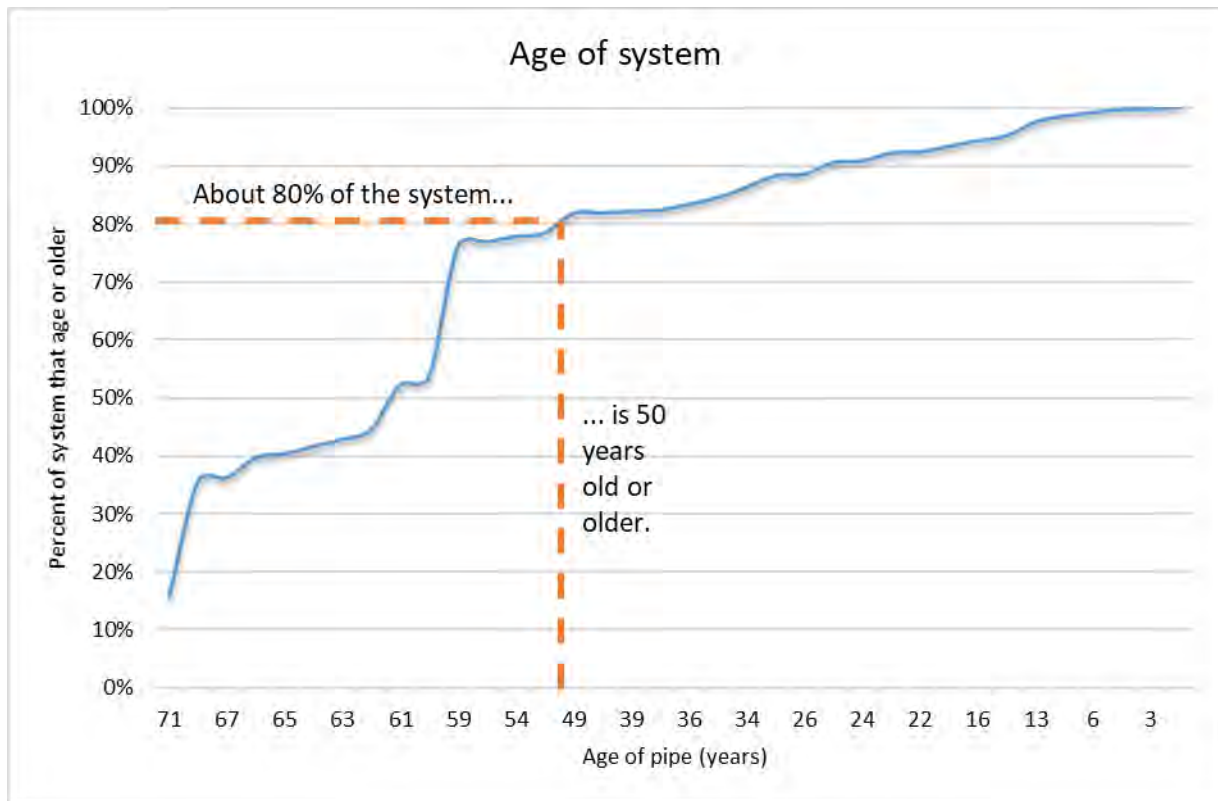
**Figure 8. Age as a percentage of collection system pipes**

The collection system gravity pipelines consist of various diameters and materials installed at various times since the 1940's. Fifty-seven percent of the systems is comprised of 6-inch diameter vitrified clay pipe; pipe diameters range from 4 inches to 18 inches and the remaining portion of the system is comprised of pipes made from a variety of materials. Pipeline sizes are shown in Table 5, and material characteristics are provided in Table 6. The system has been constructed over the past 70 years based on the data provided in the GIS. System installation data are shown in Table 7. Almost 80 percent of the collection system pipes are over 50 years old, as shown in Figure 8.

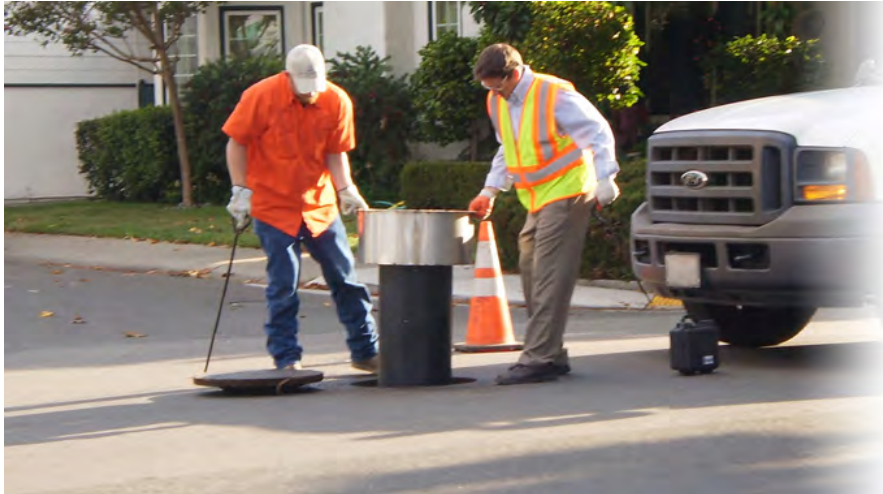
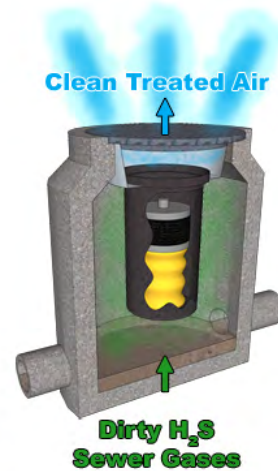
Figure 31. The Mole™ manhole insert with 20 lb. activated carbon to eliminate odors or equivalent device

3. Install passive manhole inserts with activated carbon units, as shown in Figure 31.
4. Install passive external activated carbon units, as shown in Figure 32.

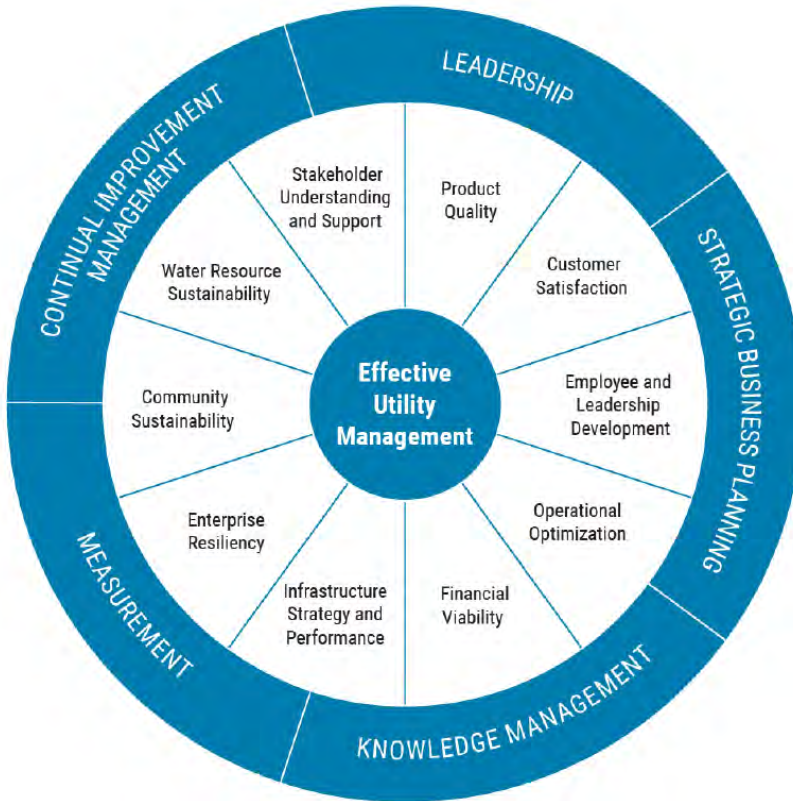
**Figure 38. The ten attributes of effectively managed utilities and five keys to management success (USEPA, 2017)**

The ten attributes are shown in Figure 38 below.
